Restoring the Link Trainer Telegon Oscillator

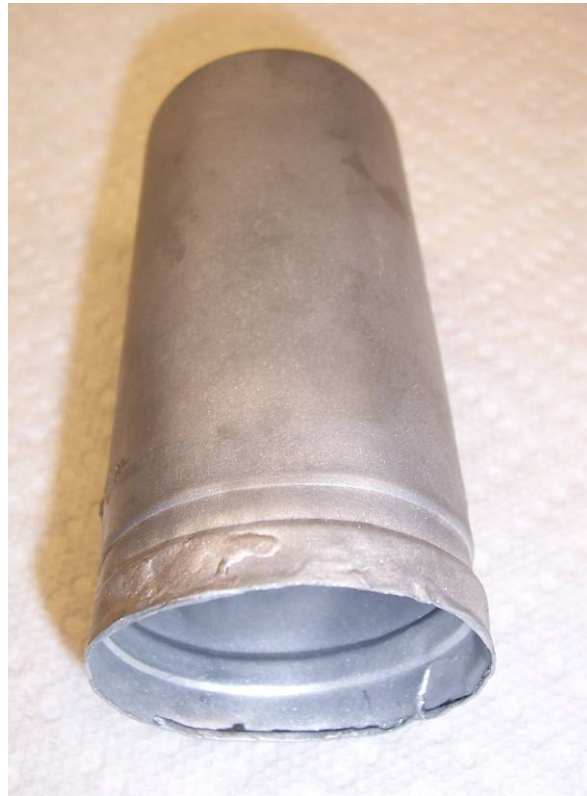
Figure 4 Capacitor C5 housing with contents removed

The removal of the electrode and interior is a messy operation and the oil filled contents are probably hazardous so wear gloves and dispose of the internals properly. The attempt to remove C5's base using a large 200W "American Beauty" soldering Iron worked but effectively destroyed the base. An alternative

suggested by others is to cut off the bottom of the capacitor in a metal lathe. Either way it is a messy process so be prepared to strike oil. After the bottom is removed the roll of foil and insulation, along with the oil, is removed and the interior cleaned out using paper towels. The cleaning process was completed by bead blasting the casing. Figure 4 shows the housing of C5 after the electrode and contents were removed and the case bead blasted.

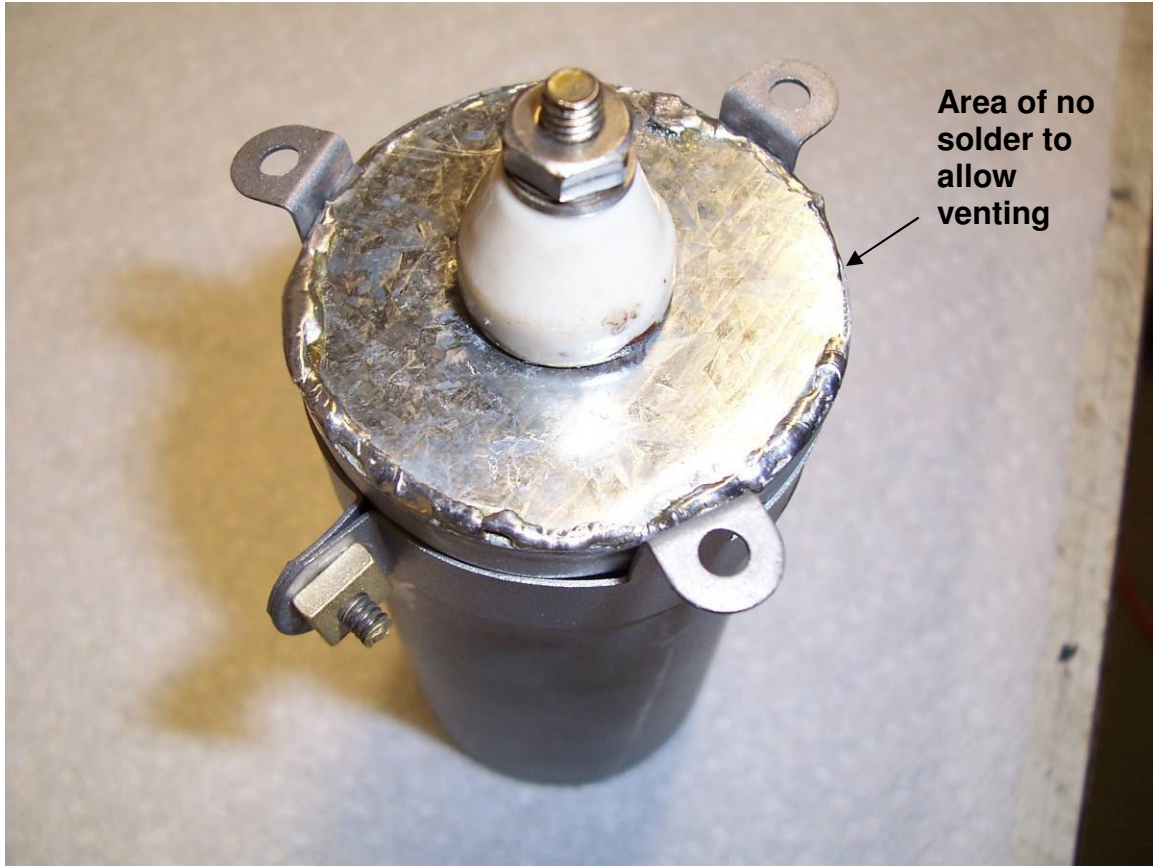
Figure 7 The finished C5 upgrade – note that solder is absent in one small area to allow for venting.

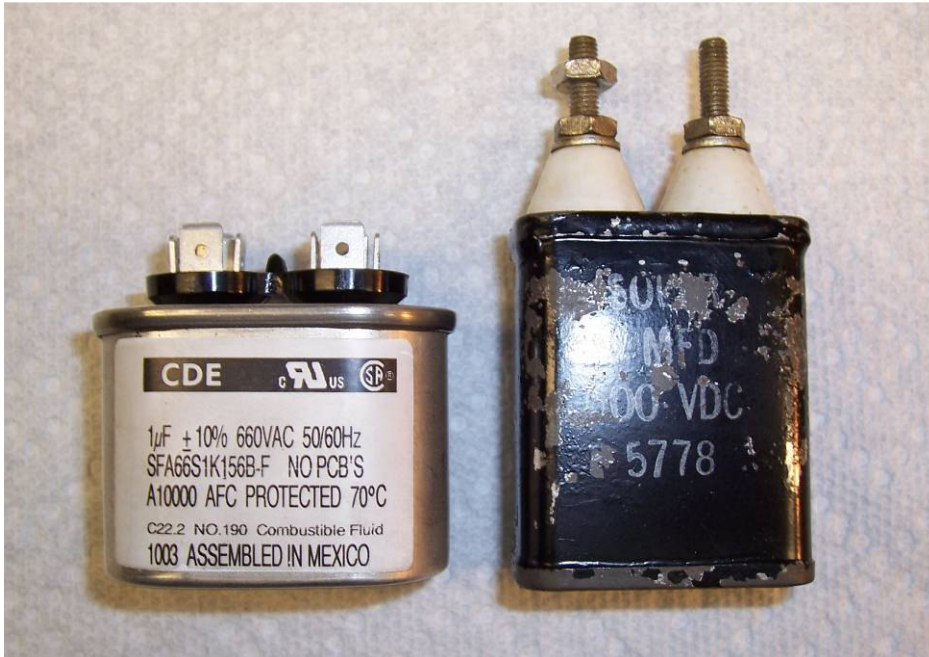
Figure 8 The new C6 on the left, original on the right

C6 is a 1uF high voltage AC type capacitor and is DC rated to 600 volts. It mounts to the chassis with a clamp around its base. The capacitor selected to replace this is 1uF with a 660 VAC rating. AC voltage ratings are typically lower than the allowable DC values and the specific specifications relate to applied current, ESR, frequency and dissipation factor. In terms of a pure AC/DC

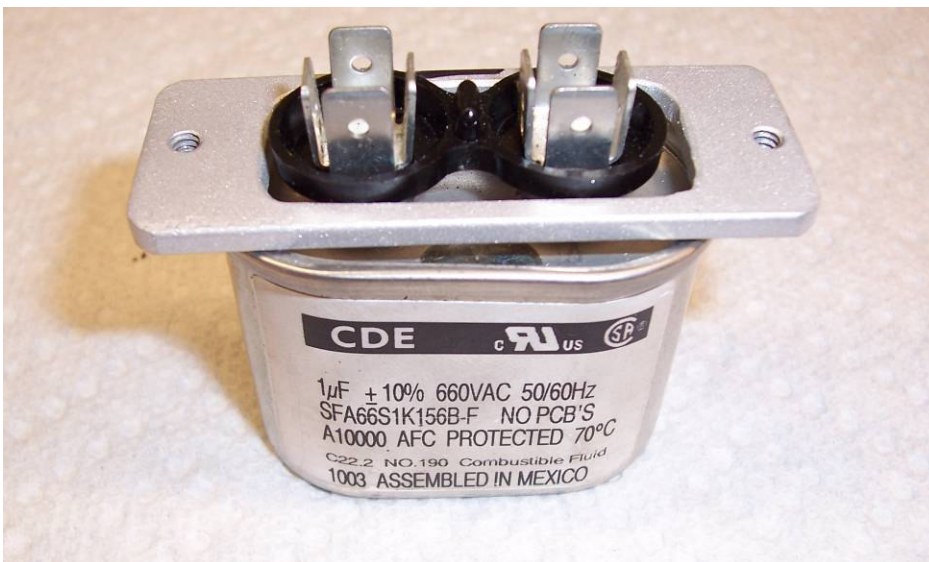
Figure 9 The new C6 with custom clamping plate fabricated from flat aluminum bar stock 1/8 in. thick.

comparison the ACV rating X 1.414 is a relatively conservative means of predicting the DC equivalent, thus $660\text{VAC} \times 1.414 = 933$ volts DC which exceeds the original 600 VDC rating. The original capacitor used insulated ceramic stud terminals however, the new capacitor utilizes push on spade type terminals, thus, the lugs were removed from the wires and push on terminals were soldered to the wires. Mounting of the new C6 capacitor required the fabrication of a custom clamping plate that was designed to reuse the original chassis screw holes. The clamp was secured to hold the capacitor to the chassis using two, 2 inch long brass 6-32 flat head screws.

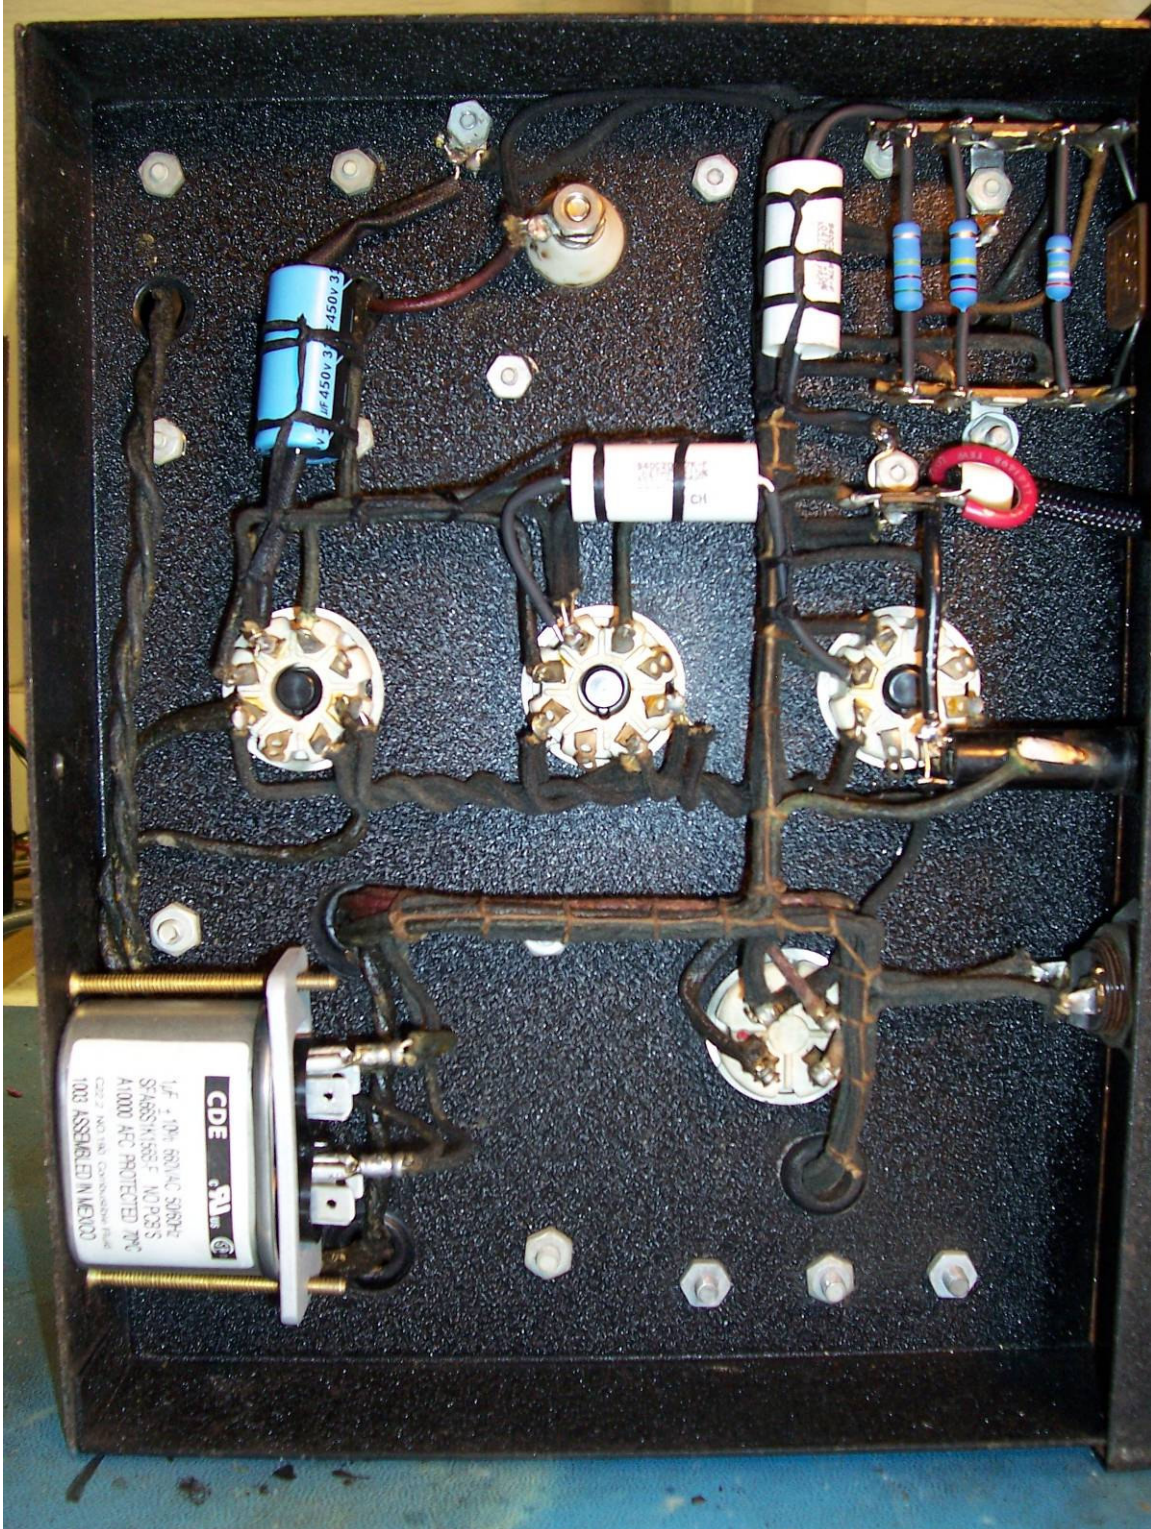
Figure 10 The completed under chassis

Continue by replacing the other capacitors one at a time. C4 is polarized and it is necessary to ensure that proper polarization is maintained. The negative side of C4 should connect to chassis ground. If possible you can reuse the sleeve material use on the leads of the original capacitors, however, if this is not possible use small diameter heat shrink tubing cut to length and then shrunk over the lead. If possible use lead based solder to restore all of the connections. The capacitors should be laced in a manner similar to that shown in Figure 10.

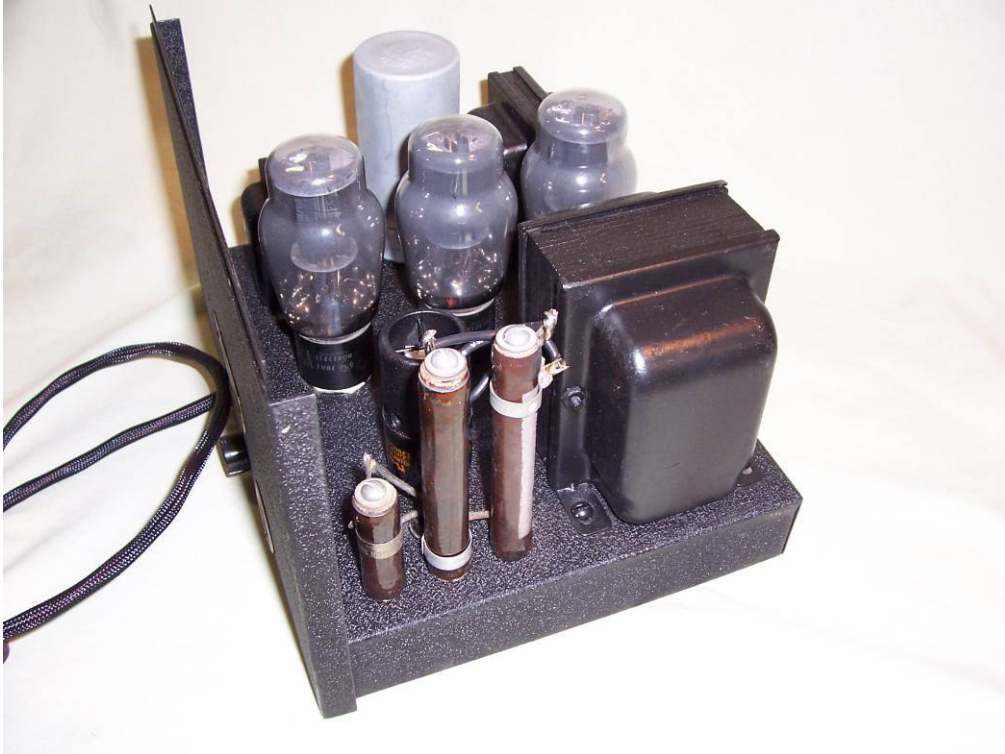
Figure 14 The completed Telegon oscillator, View 1

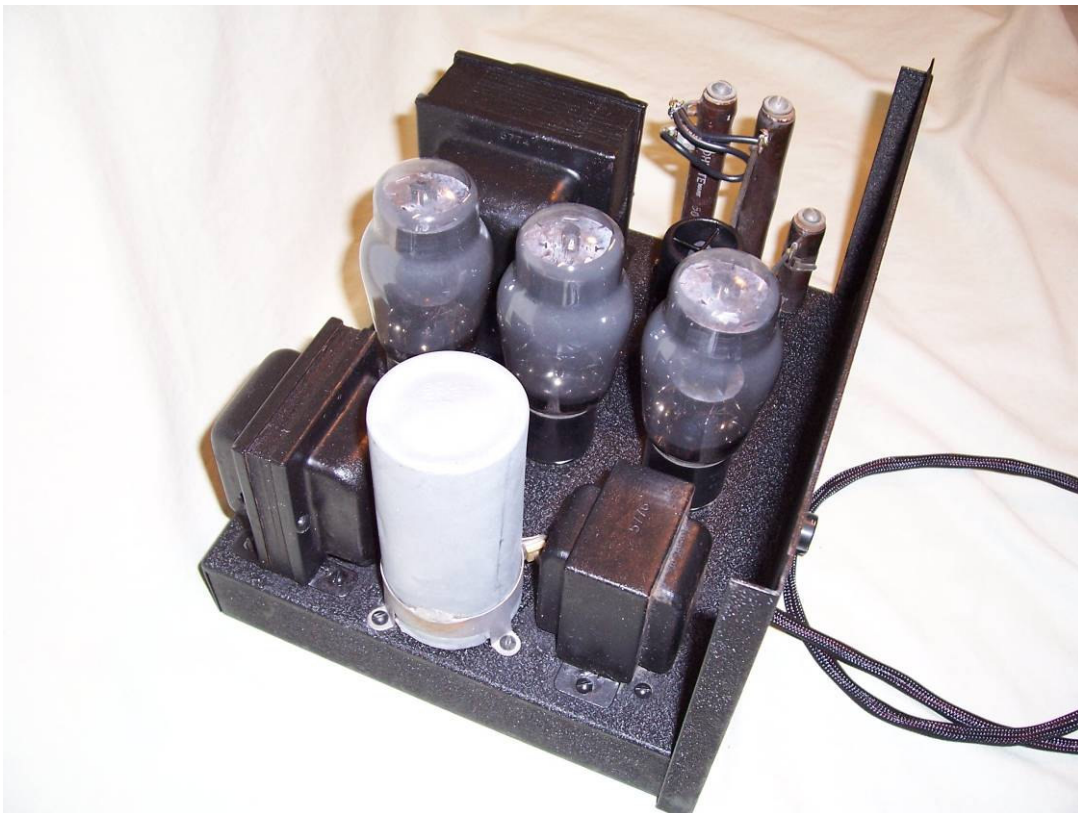
Figure 15 The completed Telegon oscillator view 2

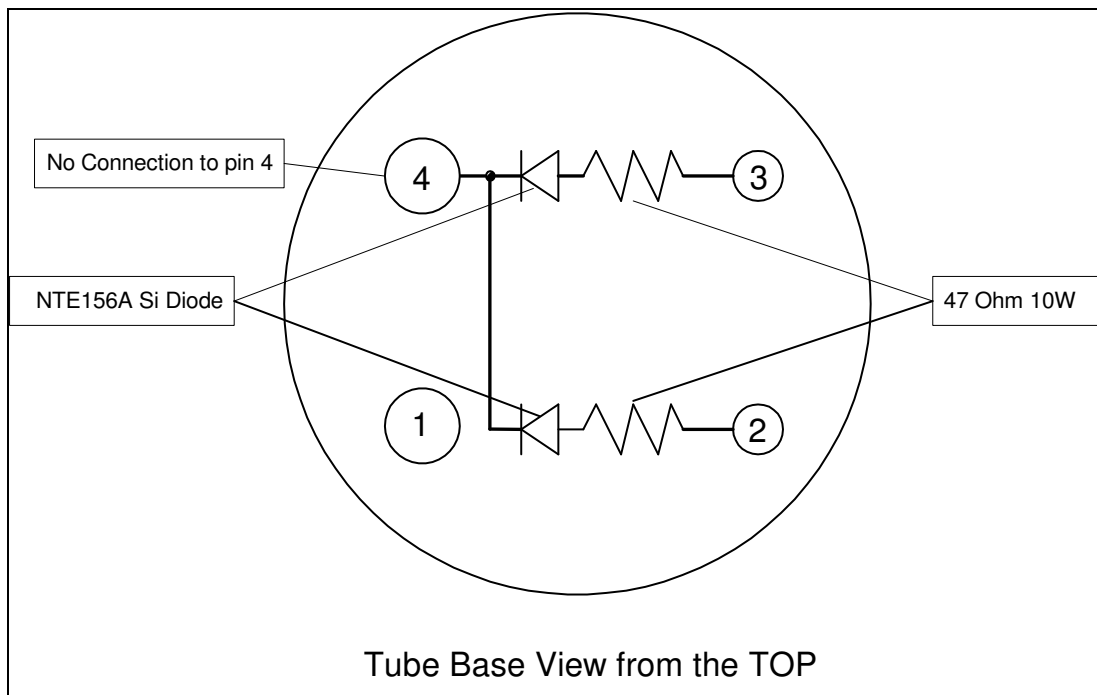
Figure 16 Schematic of the solid state "83V" rectifier, note that there is no connection to pin 1

The basic solid state rectifier design consists of two silicon diodes of the 1N4007 type that are rated to a peak inverse voltage of 1000 volts. Two 47 ohm power resistors are placed in series with each diode to provide a voltage drop that is somewhat comparable to forward voltage drop exhibited by the 83V (15V @ 300 mA) although in the case of a resistor, the voltage drop will be a function of forward current. The 47 ohm resistors exhibit a 14.1 volt drop at 300 mA plus the V_f of the diodes which result in a nearly comparable V_f for the 83V at 300mA.

Figure 17. Figure 16 displays the schematic of the solid state rectifier and identifies the components used to construct the replacement rectifier.

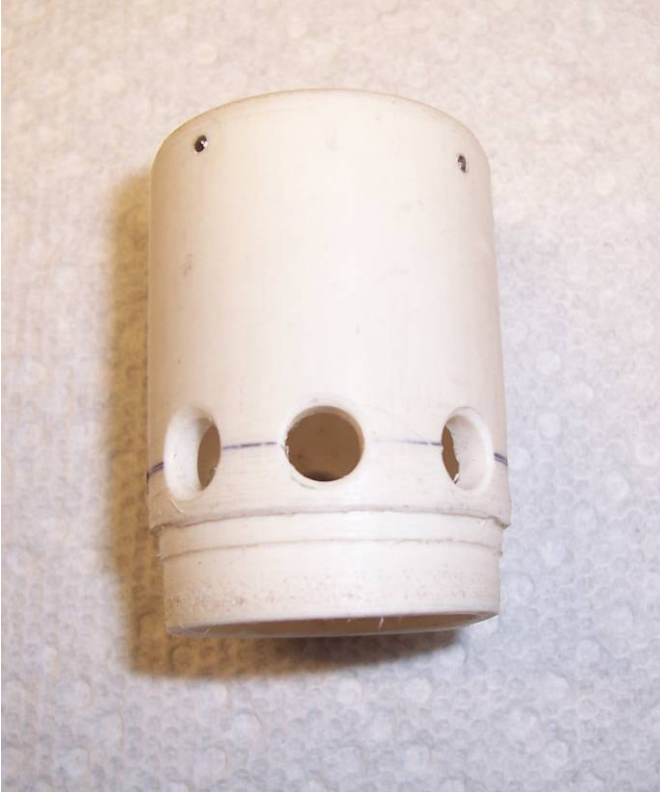
Figure 19 Protective cover for the solid state rectifier made from $\frac{3}{4}$ inch schedule 40 PVC

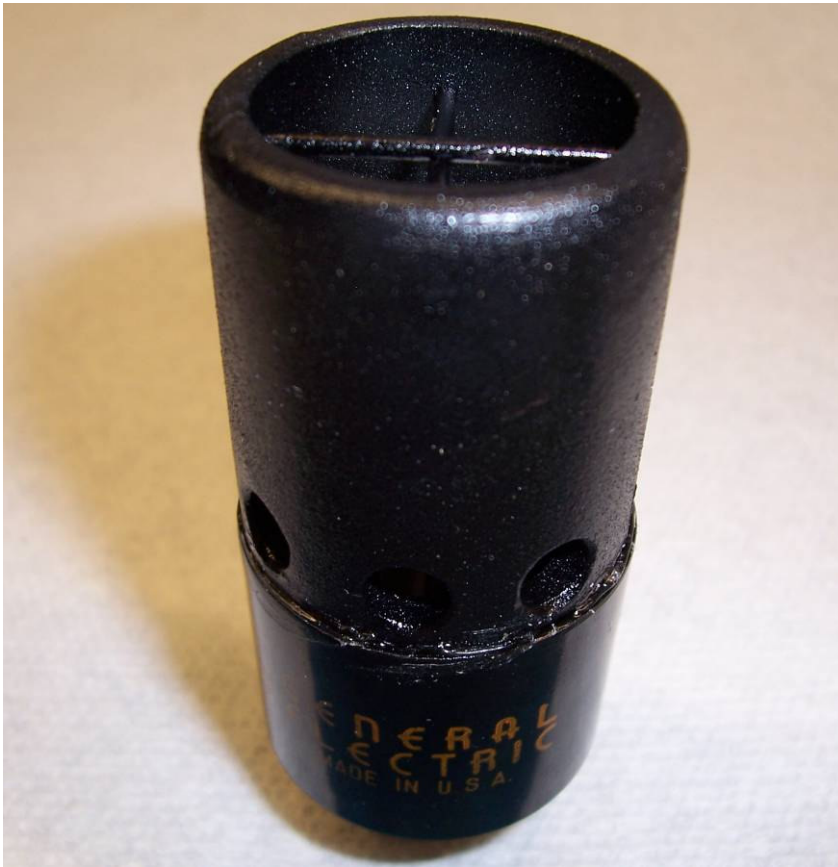
Figure 21 The completed solid state "83V" rectifier

in Figure 20. The completed cover was painted black and then glued onto the tube base. The completed solid state rectifier is shown in Figure 21.
